MISCELLANEOUS PAPER S-76-22

6 AIRFIELD PAVEMENT EVALUATION,
BUTTS ARMY AIRFIELD,
FORT CARSON, COLORADO.

BUTTS ARMY AIRFIELD

FORT CARSON, COLORADO

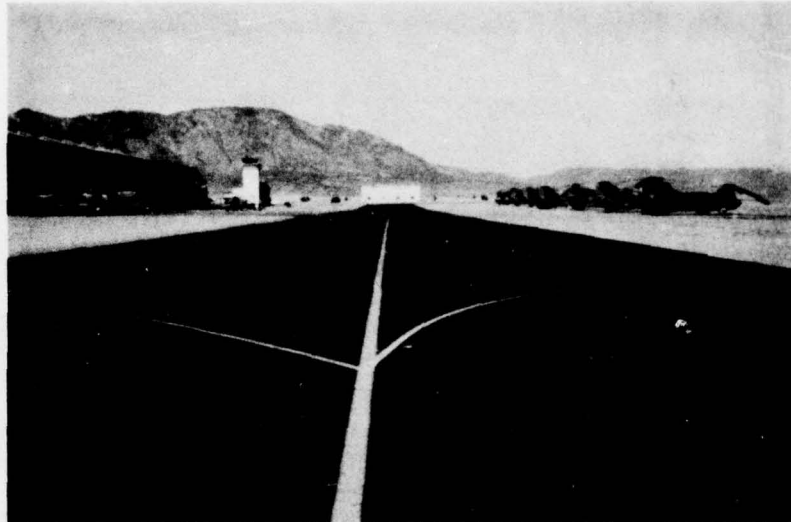
The seal placed in the hover lane covered only a 65-ft-wide area (Photos 1 and 2) of the existing 150 ft. The seal on the primary runway was also only about 65 ft wide (Photo 3).

Photo 1. Center 65 ft of hover lane which had received hot-mix plant seal in 1973

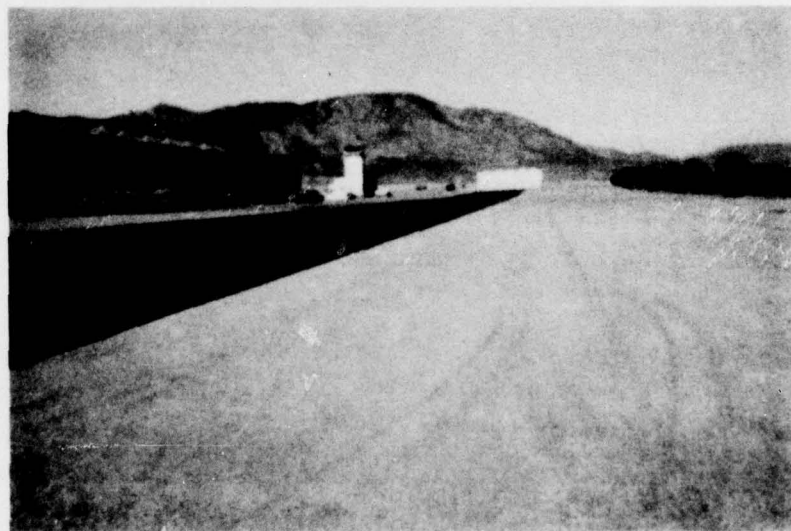
Photo 2. Condition of unsealed portion of hover lane

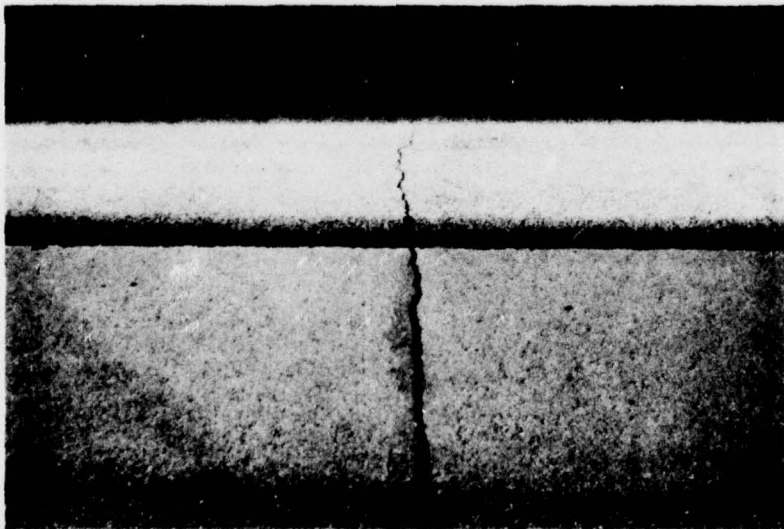
9. The general condition of the pavement surfaces at the time of the inspection (6 November 1975) was very good. The primary runway had contained cracks prior to the placement of the plant seal and these cracks had not been sealed (see Photo 4). These cracks have reflected through the plant seal (Photo 5). These cracks will eventually have to be sealed if ravelling or spalling becomes a problem. The pavement surface on the primary runway also contained some scratch marks from the skids of landing helicopters; however, this is not affecting the surface as there was no evidence of any gouging or rutting (Photo 6). The PCC parking apron was in excellent condition, with no evidence of any structural defects (Photo 7). The area of the hover lane that had not received plant seal contained some shrinkage cracks (Photo 8). One area at the southeast end of the hover lane that had been overlaid with the plant seal was rutted by the skids of a Cobra helicopter (Photo 9). The plant seal had probably not cured sufficiently when it was used by the helicopter for landing. The crosswind runway was also in very good condition (Photo 10). This runway is used mainly for landing helicopters and has many skid marks on the surface; however, the skids are not damaging the pavement. This runway does not contain the shrinkage cracking evidenced on the primary runway.

Photo 4. Cracks at edge of runway indicate that no sealing was done prior to placement of hot-mix plant seal in 1973

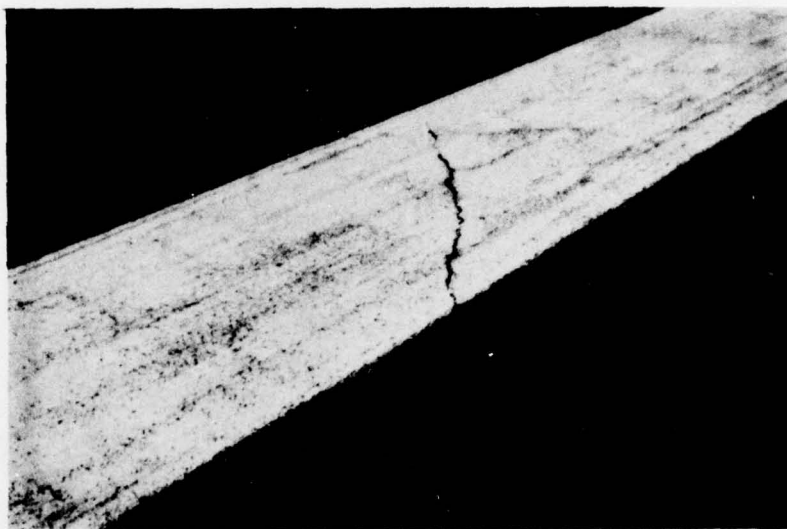
Photo 5. Reflection crack in surface of primary runway

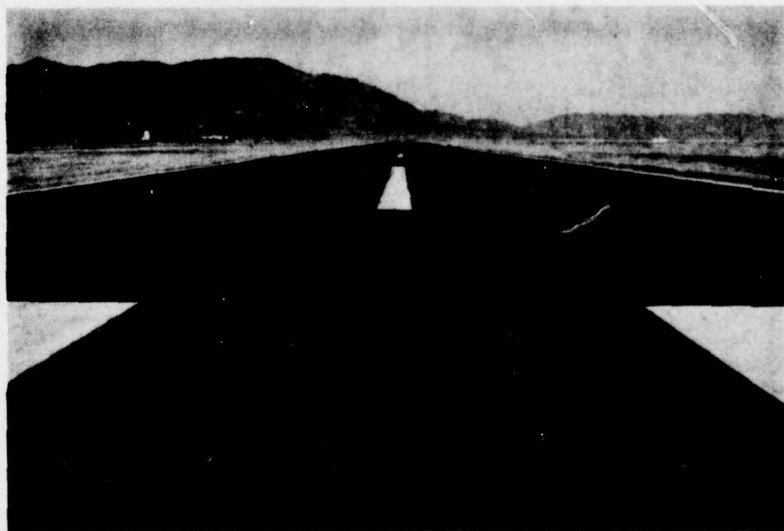
Photo 6. Primary runway with skid marks from landing helicopters
